SEELEYS MILL DAM

NJ 00065

PHASE 1 INSPECTION REPORT
NATIONAL DAM SAFETY PROGRAM

April, 1979

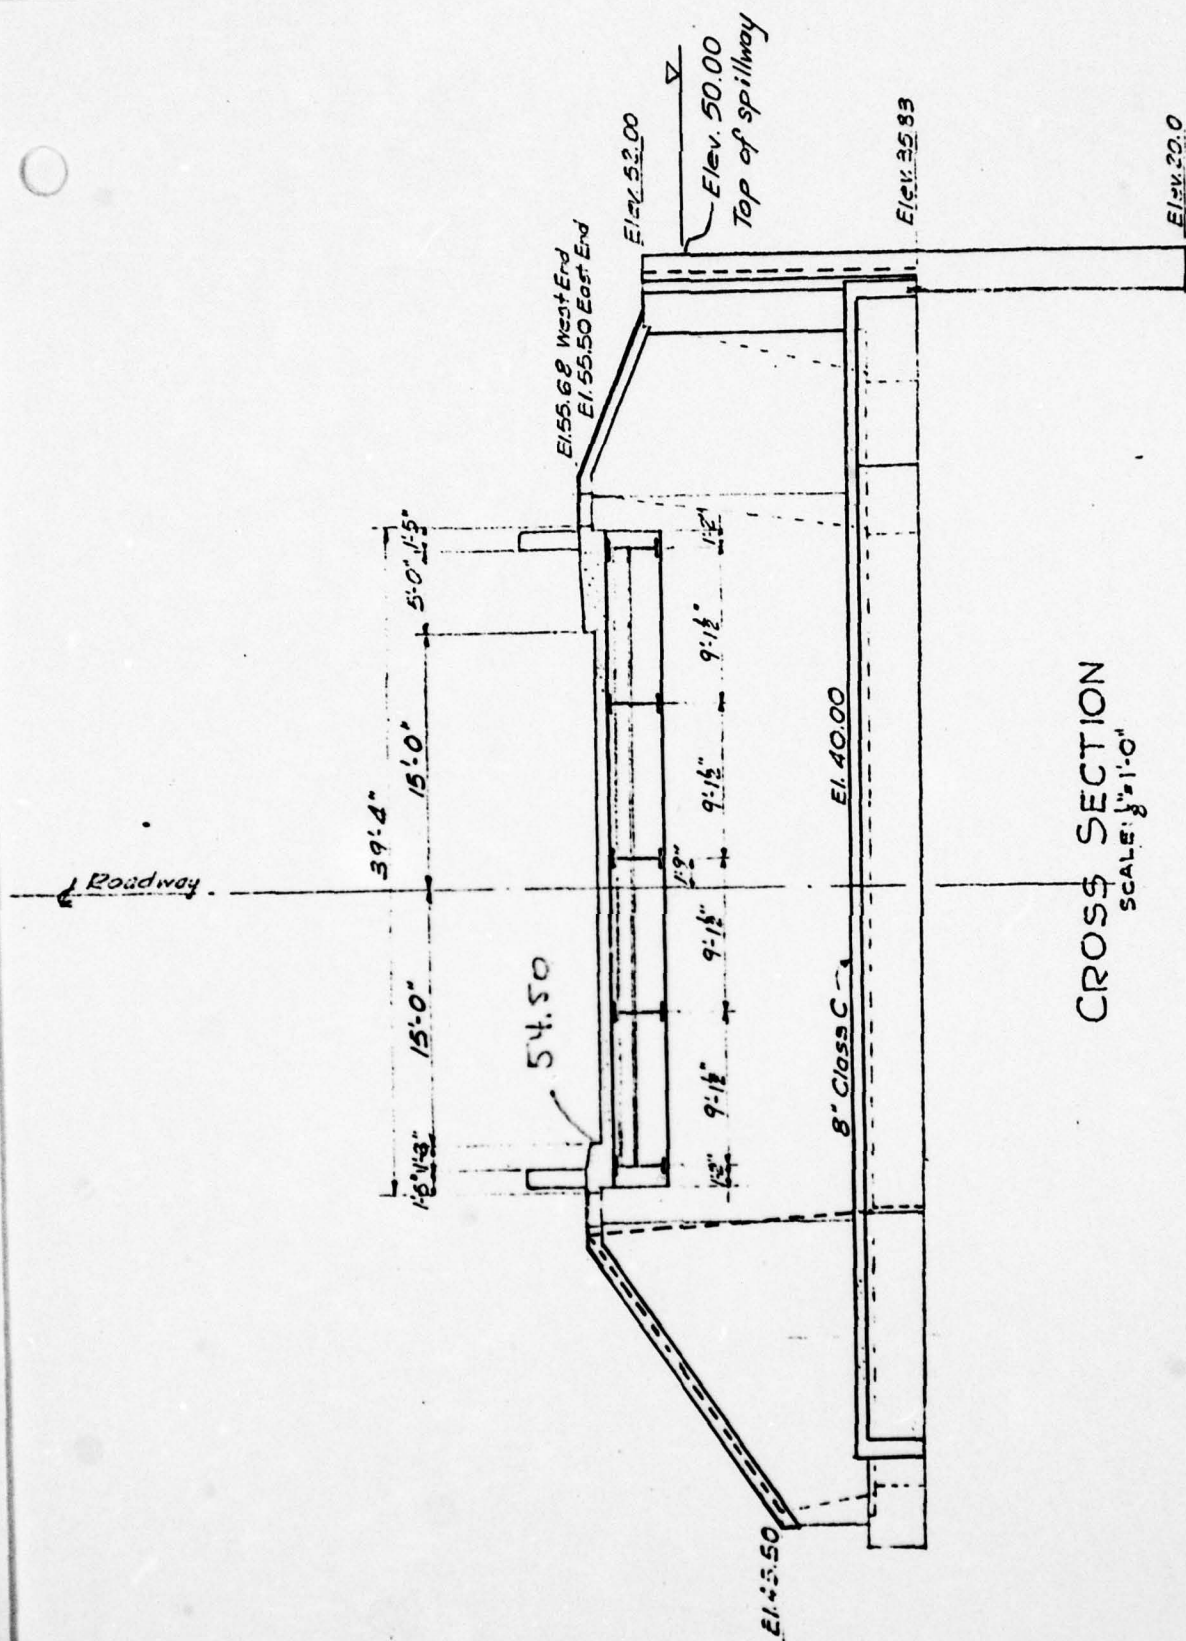
BRIDGE SECTION
FIGURE 3

CROSS SECTION
SCALE: 1/8" = 1'-0"

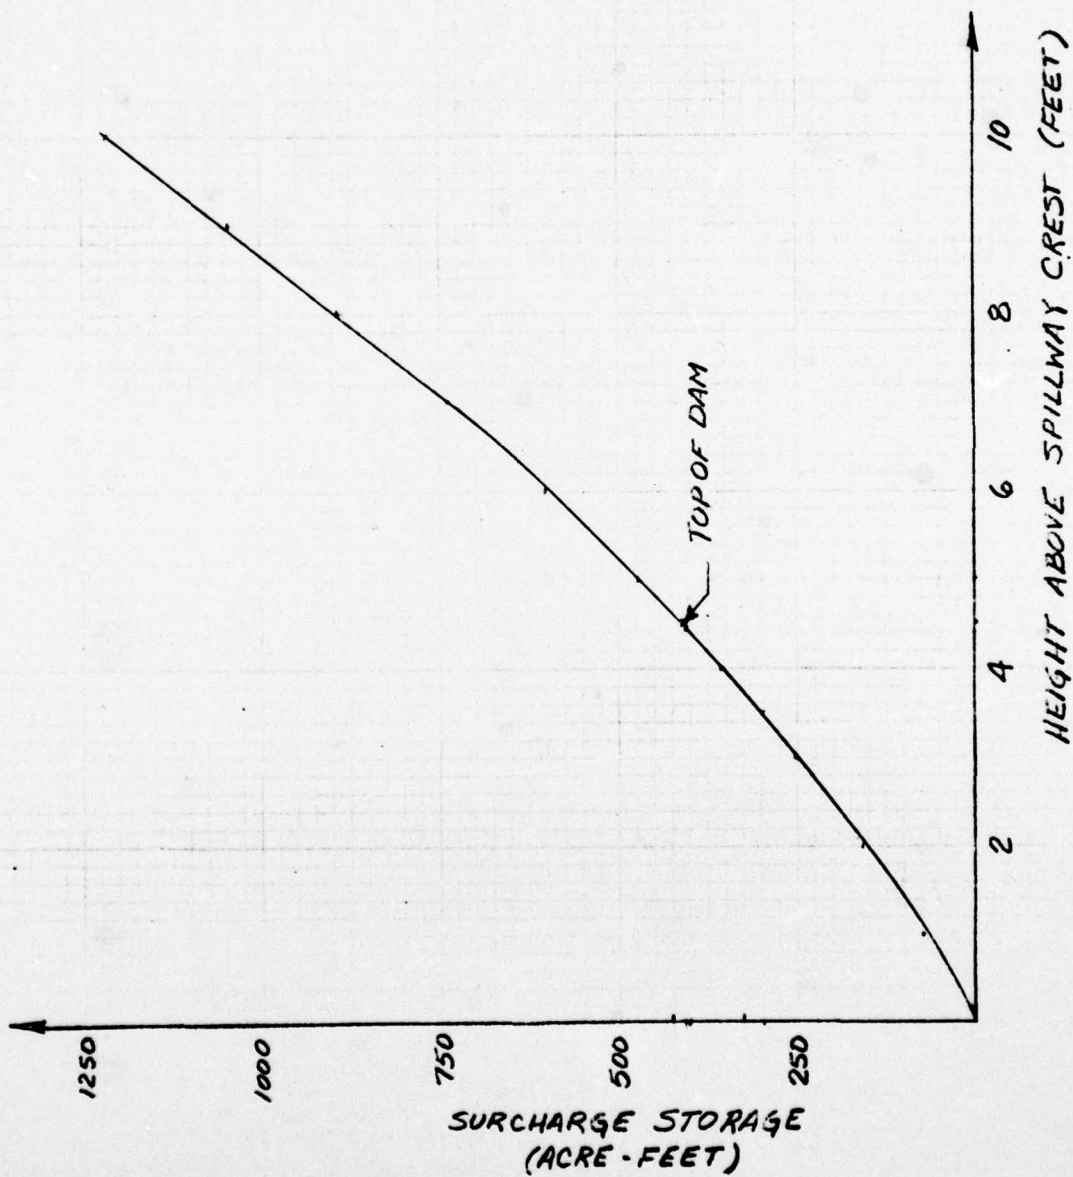
SUBJECT STAGE STORAGE CURVE
SEELEYS MILL DAM INSPECTION

<u>HEIGHT ABOVE CREST (FT.)</u>	<u>STORAGE (ACRE-FT.)</u>
1	74
2	158
3	253
4	359
5	475
6	602
7	739
8	887
9	1045
10	1215
